PROGRESS REPORT: GAS TURBINE REGENERATOR
FOULING INVESTIGATION.

GAS TURBINE REGENERATOR FOULING
INVESTIGATION

15 October 1964

Technical Report No. 21

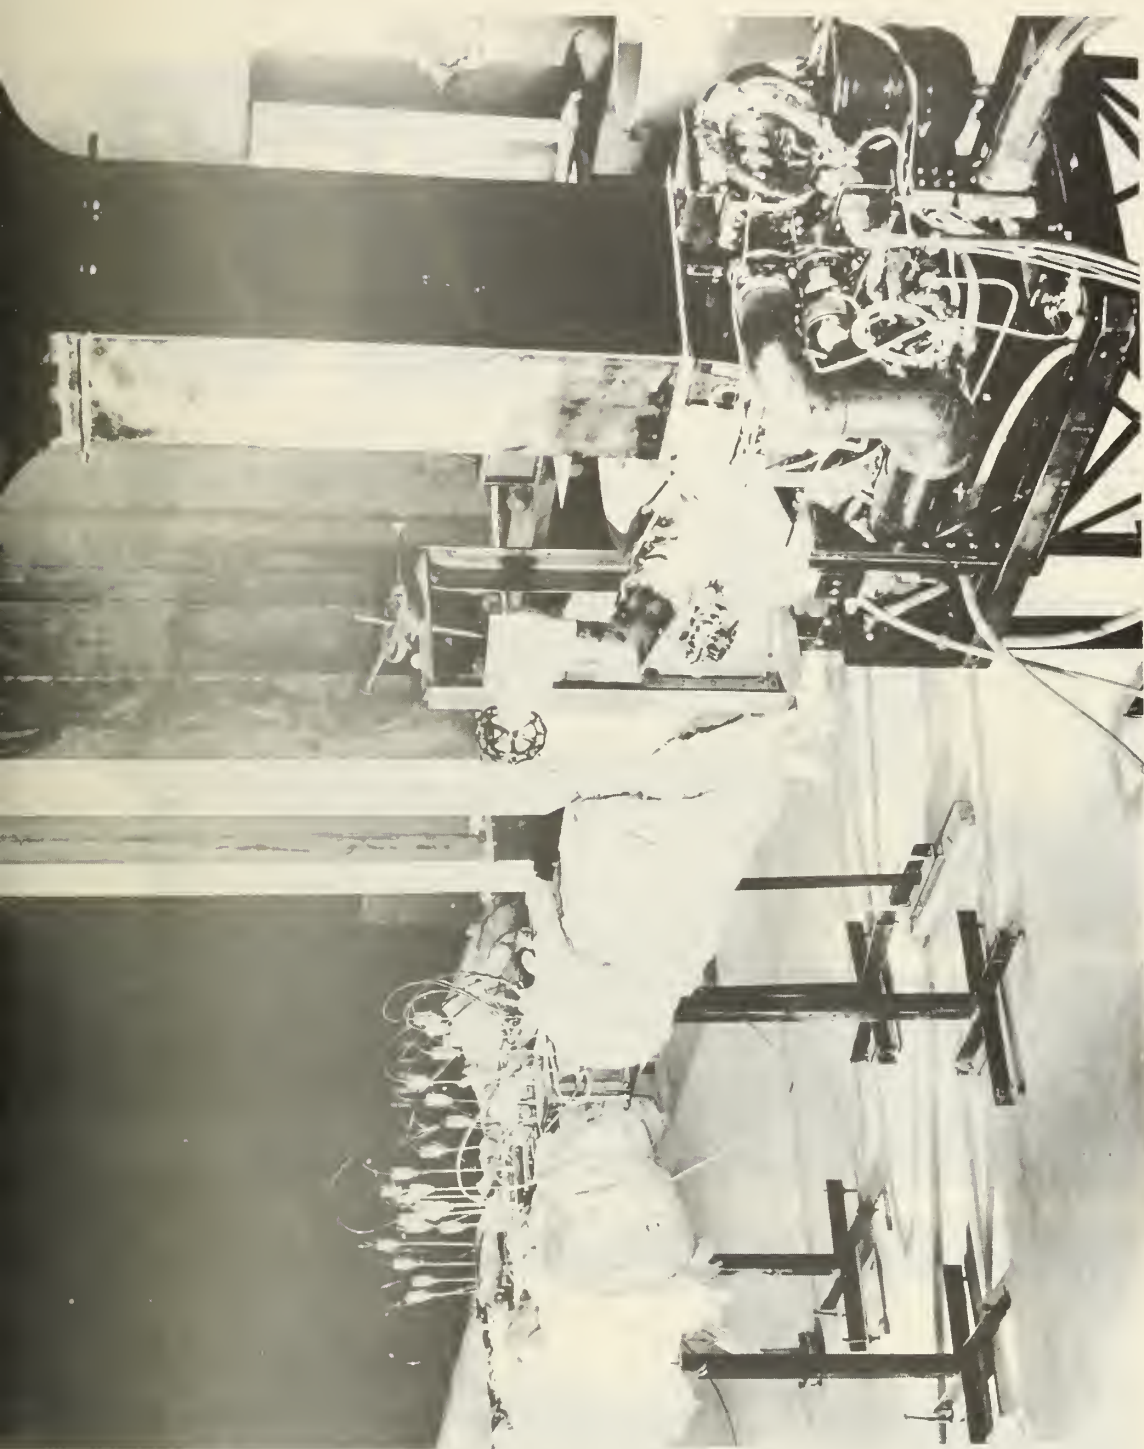
FIGURE 1. GENERAL VIEW OF TEST RIG.

The present state of the facility includes an active and thoroughly instrumented rig for the evaluation of regenerator matrix fouling performance, installed in the turboprop cell of the Department of Aeronautics, and shown in Figures 1 and 2. A segmented counter-flow heat exchanger designed to run in parallel with this fouling unit is under design and construction. A large air-to-steam rig for evaluating heat exchanger performance of larger-sized test matrices is also under construction. The fouling rig has already produced substantial engineering information.

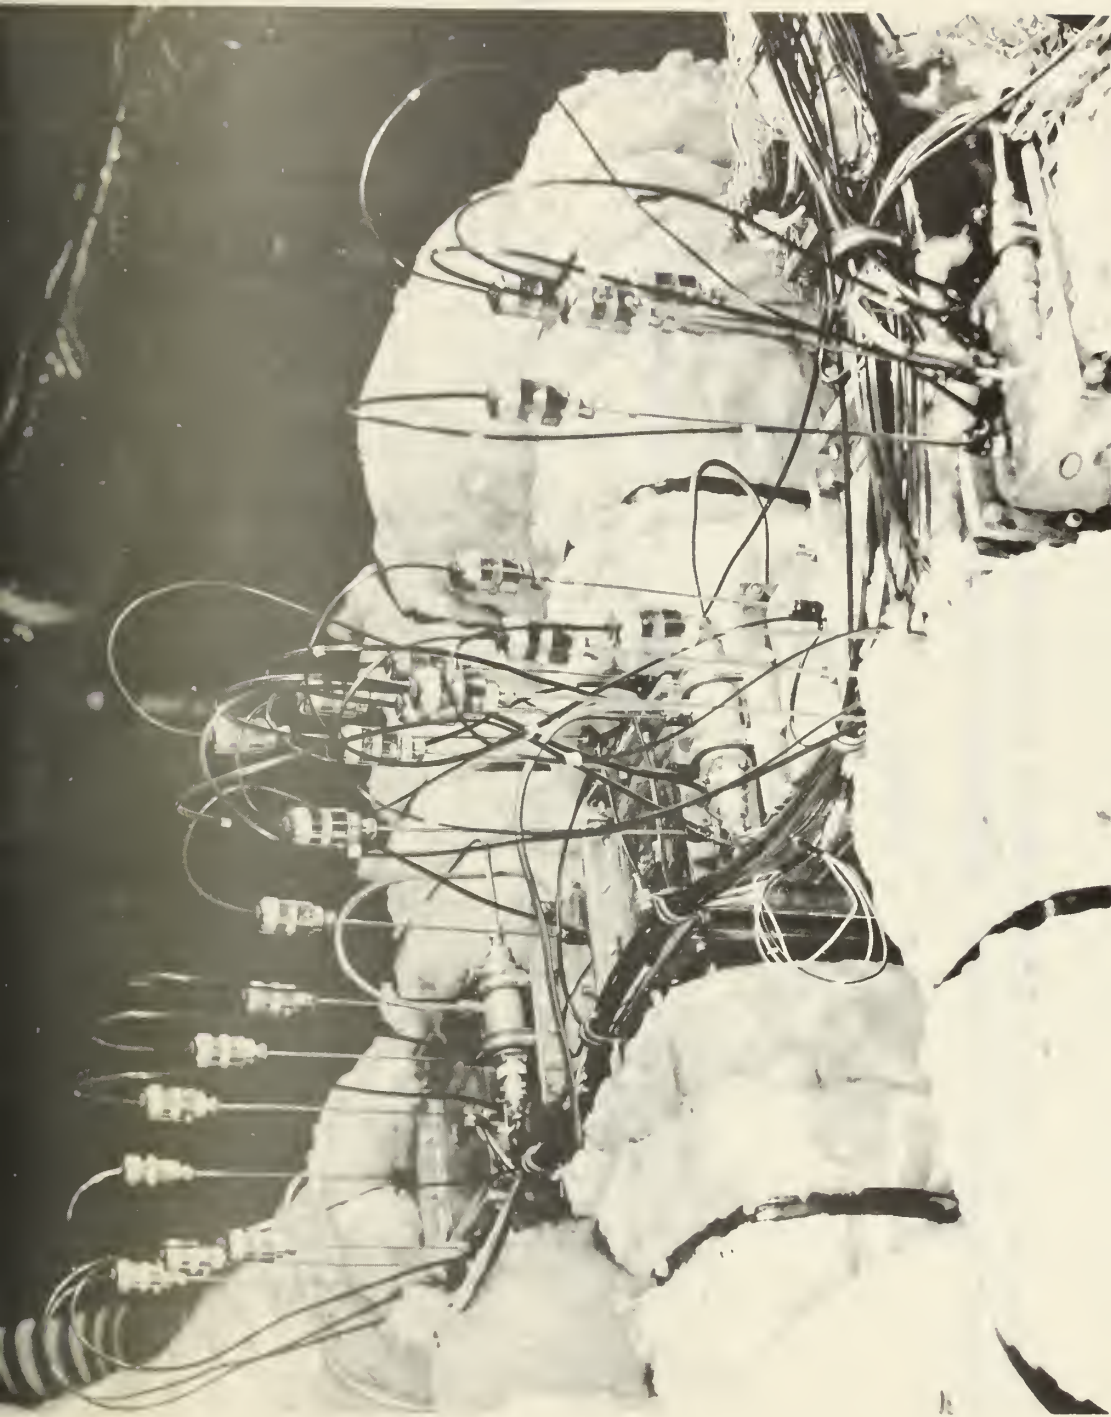
FIGURE 5. CROSS COUNTERFLOW INSTALLATION AND INSTRUMENTATION OF THREE TEST MODULES .
